Inspection report

Road: Kentmire Av	Division:	start MH: SW 5
Place: Kentmire School	District:	end MH: Main Line
Location: Footpath or verge	Tape No.: 1	Total length: 37.7 m

Purpose: Asset condition	Shape/Size: Circular 150
Use: Surface water	Material: Vitrified clay Pipe length:
Catchment:	Lining:
	Category:

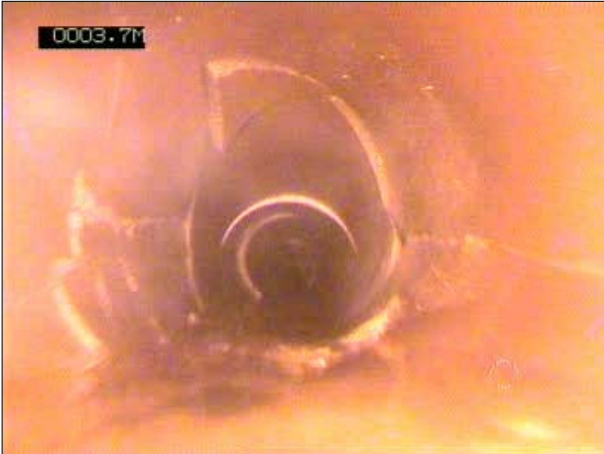
Photo: 109_1a
 3.7m, Multiple Cracks, from 12 to 12 o'clock, Start

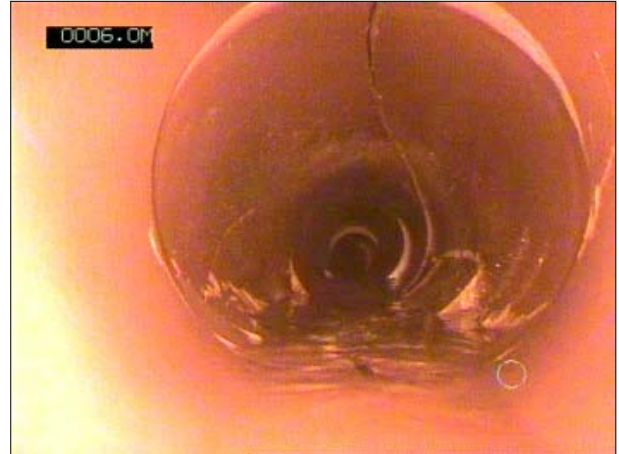
Photo: 112_4a
 6m, Multiple Cracks, from 07 to 03 o'clock, Start

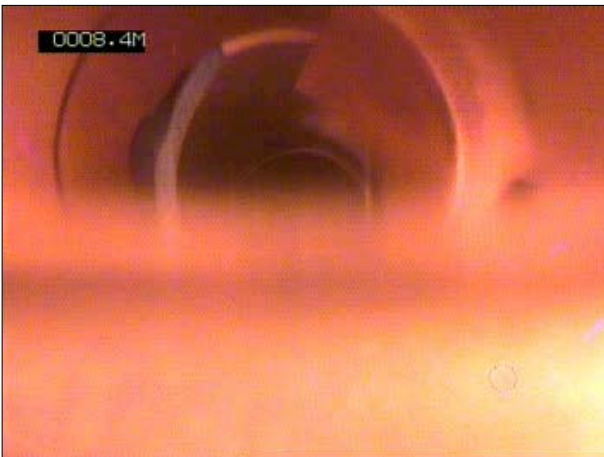
Photo: 114_6a
 8.4m, Sewer Broken, from 12 to 12 o'clock

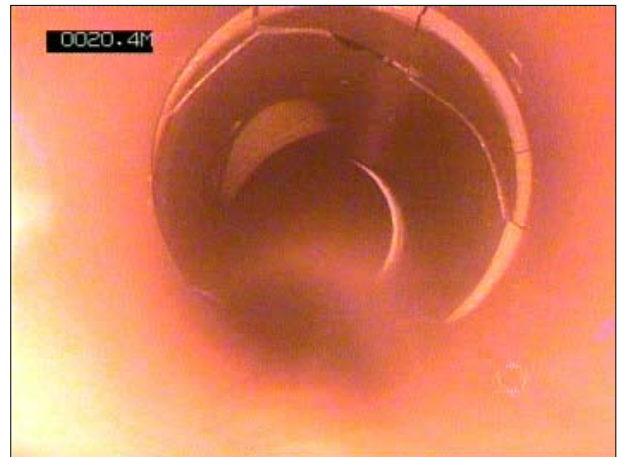
Photo: 116_8a
 20.4m, Multiple Cracks, from 10 to 03 o'clock
